# Operating Experience Summary

Summary 2000-07

# Operating Experience Summary 2000-07

## March 28 through April 12, 2000

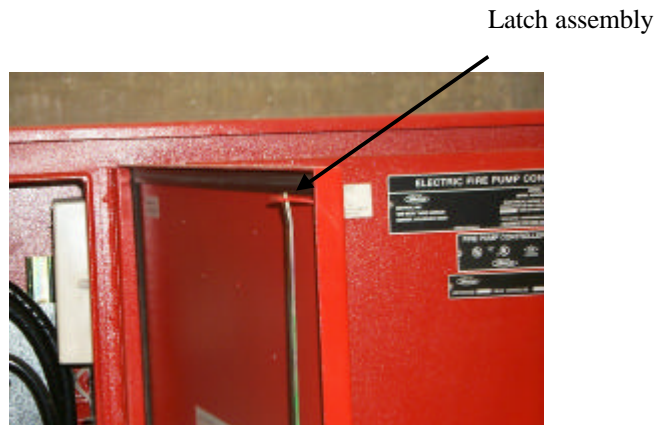
On March 15, 2000, at the Hanford Site, an electrician attempted to close a 480-V AC cabinet after taking voltage readings for a flow test on a fire pump, when the bottom bar of the slide mechanism fell to the floor and the upper bar fell into the electrical cabinet. Though no personnel injuries or electrical problems occurred, there was a potential that the upper bar could have come in contact with live 480-V electrical lugs and could have caused arcing in the cabinet, endangering workers' safety. (ORPS Report RL--PHMC-S&W-2000-0004)

Investigators discovered that the crew was wearing only regular personal protection equipment, as it was not considered an electrical (hot) work assignment. The electrician retrieved the bottom slide and upper bar (Figure 6-1). The crew reassembled the lower and upper guide mechanisms of the cabinet door and restored the latching system to working condition. The electrician then checked the door mechanism of the adjacent cabinet and found that the lower slide bar was bent and had slipped out of its guide. The crew straightened the bent slide, put it back in its original position and shut the door. The team's craft supervisor notified the line management about the corrective actions taken. Investigators from Operations and Maintenance inspected the repaired latch assembly and determined that there was no potential for the upper bar to contact the energized sources (Figure 6-2). The operations Management checked similar latch mechanisms of the doors of 12 other electrical cabinets in the area as a precaution and found all in sound working condition.

**Figure 6-1. Door Latch Assembly**

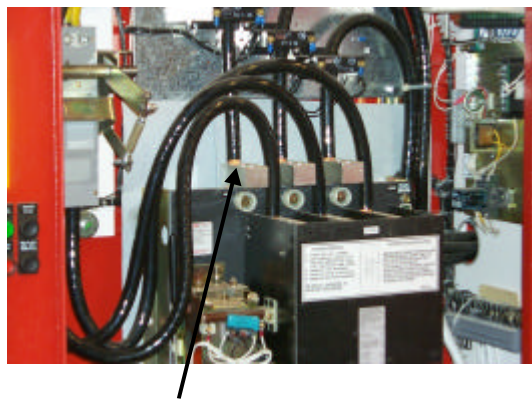
**Figure 6-2. Exposed Energized Contacts**
